HOME REPORT

REUL NA MARA

CLADDACH KIRKIBOST
ISLE OF NORTH UIST
HS6 5EP

ENERGY PERFORMANCE CERTIFICATE

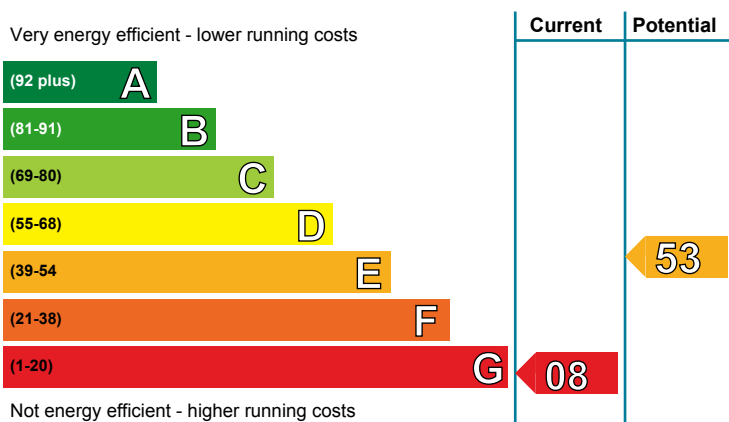
Energy Efficiency Rating

This graph shows the current efficiency of your home, taking into account both energy efficiency and fuel costs. The higher this rating, the lower your fuel bills are likely to be.

Your current rating is **band G (8)**. The average rating for EPCs in Scotland is **band D (61)**.

The potential rating shows the effect of undertaking all of the improvement measures listed within your recommendations report.

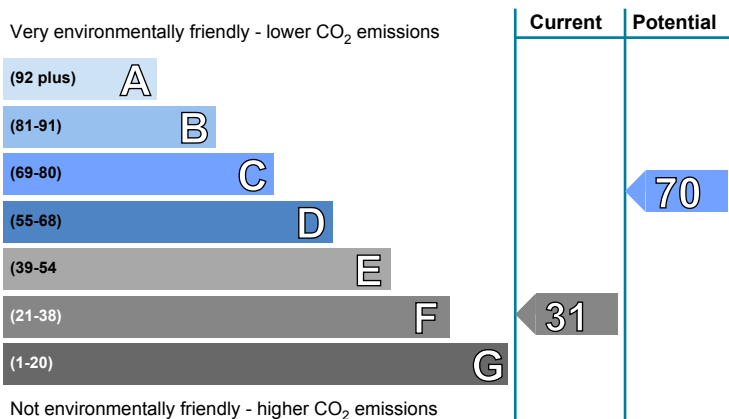
Environmental Impact (CO₂) Rating

This graph shows the effect of your home on the environment in terms of carbon dioxide (CO₂) emissions. The higher the rating, the less impact it has on the environment.

Your current rating is **band F (31)**. The average rating for EPCs in Scotland is **band D (59)**.

The potential rating shows the effect of undertaking all of the improvement measures listed within your recommendations report.
