HOME REPORT

NURSE'S COTTAGE

**GRIMINISH
ISLE OF BENBECULA
HS7 5QA**

Energy Performance Certificate (EPC)

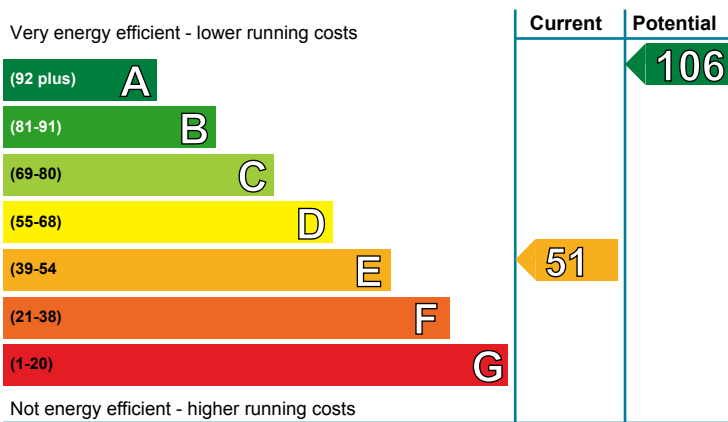
Energy Efficiency Rating

This graph shows the current efficiency of your home, taking into account both energy efficiency and fuel costs. The higher this rating, the lower your fuel bills are likely to be.

Your current rating is **band E (51)**. The average rating for EPCs in Scotland is **band D (61)**.

The potential rating shows the effect of undertaking all of the improvement measures listed within your recommendations report.

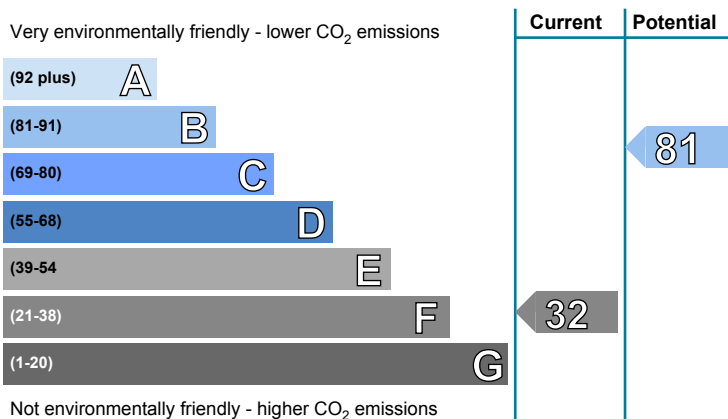
Environmental Impact (CO₂) Rating

This graph shows the effect of your home on the environment in terms of carbon dioxide (CO₂) emissions. The higher the rating, the less impact it has on the environment.

Your current rating is **band F (32)**. The average rating for EPCs in Scotland is **band D (59)**.

The potential rating shows the effect of undertaking all of the improvement measures listed within your recommendations report.
