HOME REPORT

2 TIGH A CHIDHE
LOCHMADDY
ISLE OF NORTH UIST
HS6 5AA

DM HALL
CHARTERED SURVEYORS

2 Tigh A Chidhe, Lochmaddy, Isle of North Uist, HS6 5AA

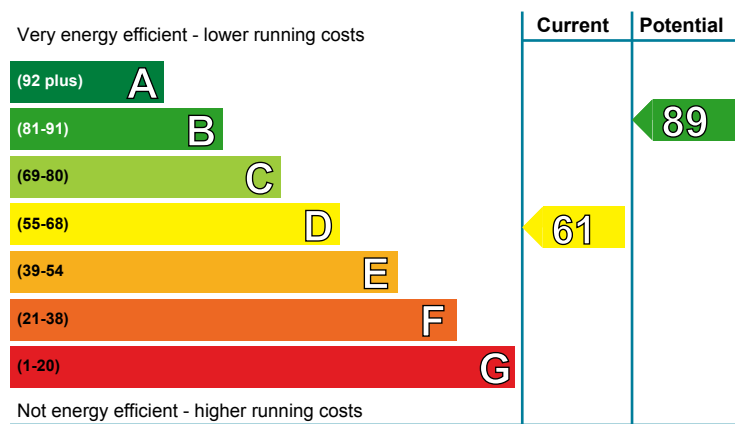
Energy Efficiency Rating

This graph shows the current efficiency of your home, taking into account both energy efficiency and fuel costs. The higher this rating, the lower your fuel bills are likely to be.

Your current rating is **band D (61)**. The average rating for EPCs in Scotland is **band D (61)**.

The potential rating shows the effect of undertaking all of the improvement measures listed within your recommendations report.

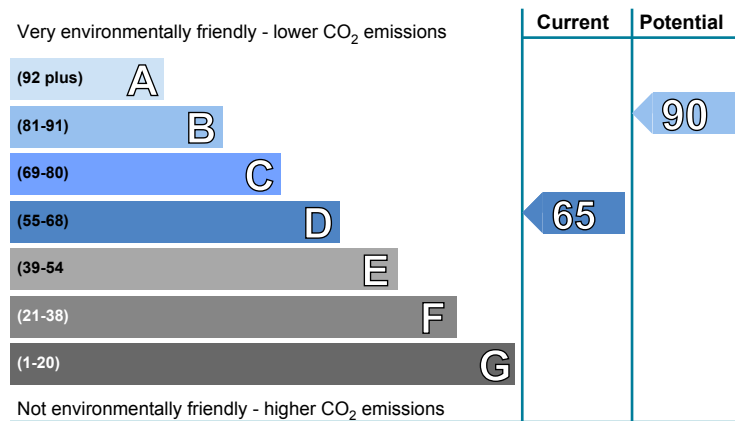
Environmental Impact (CO₂) Rating

This graph shows the effect of your home on the environment in terms of carbon dioxide (CO₂) emissions. The higher the rating, the less impact it has on the environment.

Your current rating is **band D (65)**. The average rating for EPCs in Scotland is **band D (59)**.

The potential rating shows the effect of undertaking all of the improvement measures listed within your recommendations report.
