HOME REPORT

WILLOWBANK
19 TORLUM
CREAGORRY
ISLE OF BENBECULA
HS7 5PP

DM HALL
CHARTERED SURVEYORS

Willow Bank, 19 Torlum, Creagorry, Isle of Benbecula, HS7 5PP

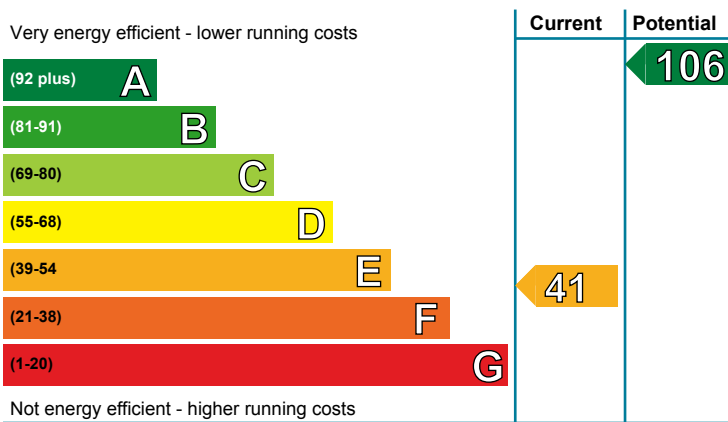
Energy Efficiency Rating

This graph shows the current efficiency of your home, taking into account both energy efficiency and fuel costs. The higher this rating, the lower your fuel bills are likely to be.

Your current rating is **band E (41)**. The average rating for EPCs in Scotland is **band D (61)**.

The potential rating shows the effect of undertaking all of the improvement measures listed within your recommendations report.

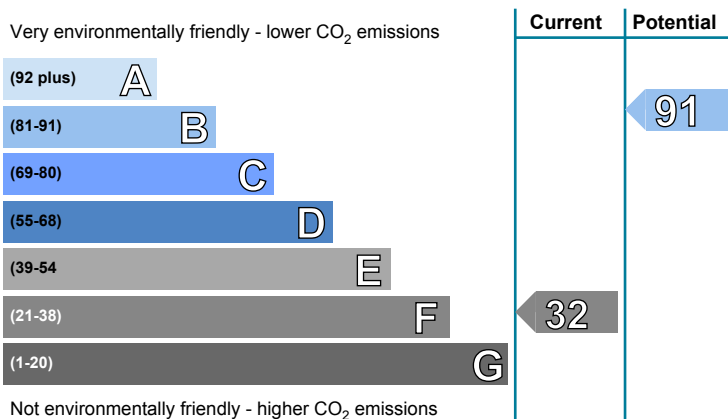
Environmental Impact (CO₂) Rating

This graph shows the effect of your home on the environment in terms of carbon dioxide (CO₂) emissions. The higher the rating, the less impact it has on the environment.

Your current rating is **band F (32)**. The average rating for EPCs in Scotland is **band D (59)**.

The potential rating shows the effect of undertaking all of the improvement measures listed within your recommendations report.
