HOME REPORT

4 CASIMIR PLACE
DALIBURGH
ISLE OF SOUTH UIST
HS8 5ST

DM HALL
CHARTERED SURVEYORS

4 CASIMIR PLACE, DALIBURGH, ISLE OF SOUTH UIST, HS8 5ST

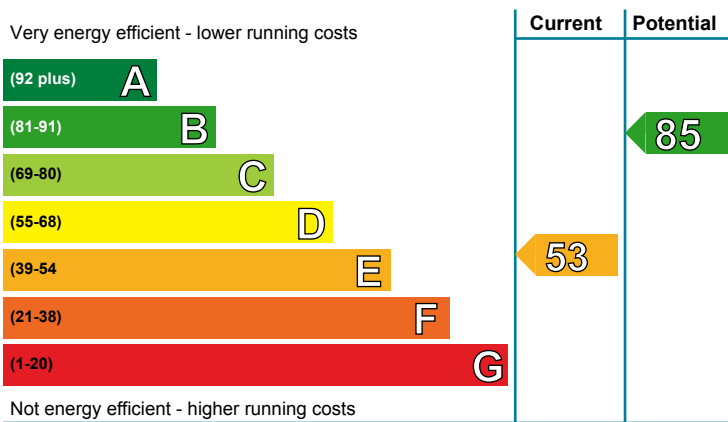
Energy Efficiency Rating

This graph shows the current efficiency of your home, taking into account both energy efficiency and fuel costs. The higher this rating, the lower your fuel bills are likely to be.

Your current rating is **band E (53)**. The average rating for EPCs in Scotland is **band D (61)**.

The potential rating shows the effect of undertaking all of the improvement measures listed within your recommendations report.

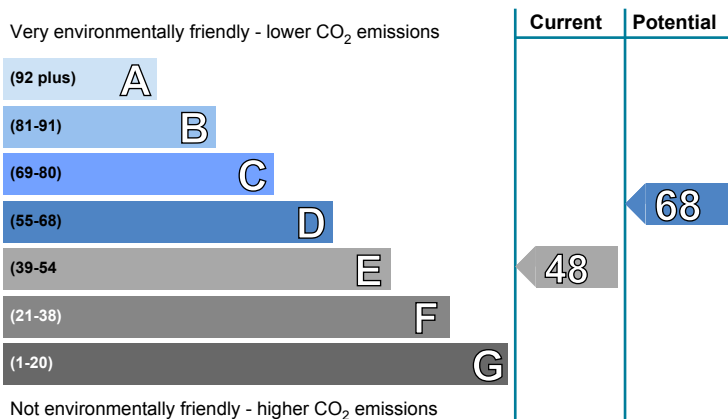
Environmental Impact (CO₂) Rating

This graph shows the effect of your home on the environment in terms of carbon dioxide (CO₂) emissions. The higher the rating, the less impact it has on the environment.

Your current rating is **band E (48)**. The average rating for EPCs in Scotland is **band D (59)**.

The potential rating shows the effect of undertaking all of the improvement measures listed within your recommendations report.
