# HOME REPORT

**RHODANTHA LEA  
5 GRIMINISH  
CREAGORRY  
ISLE OF BENBECULA  
HS7 5PN**

# Energy Performance Certificate (EPC)

RHODANTHA LEA, 5 GRIMINISH, CREAGORRY, ISLE OF BENBECULA, HS7 5PN

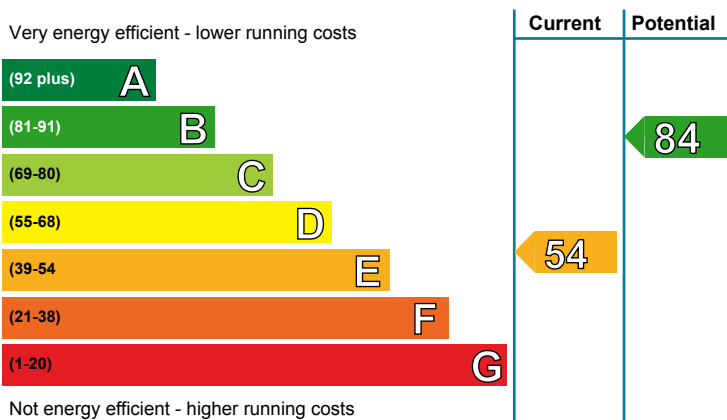
## Energy Efficiency Rating

This graph shows the current efficiency of your home, taking into account both energy efficiency and fuel costs. The higher this rating, the lower your fuel bills are likely to be.

Your current rating is **band E (54)**. The average rating for EPCs in Scotland is **band D (61)**.

The potential rating shows the effect of undertaking all of the improvement measures listed within your recommendations report.

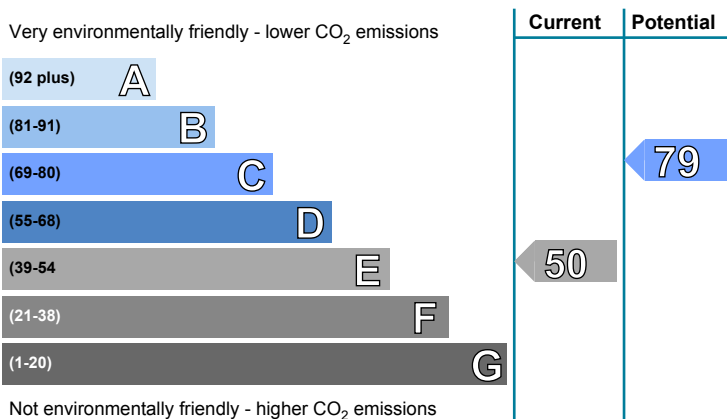
## Environmental Impact (CO<sub>2</sub>) Rating

This graph shows the effect of your home on the environment in terms of carbon dioxide (CO<sub>2</sub>) emissions. The higher the rating, the less impact it has on the environment.

Your current rating is **band E (50)**. The average rating for EPCs in Scotland is **band D (59)**.

The potential rating shows the effect of undertaking all of the improvement measures listed within your recommendations report.
